SEA WALL 2022

Following severe storms at end of 2021, the seawall at Laigh Isle was breached.

SEA WALL

2022

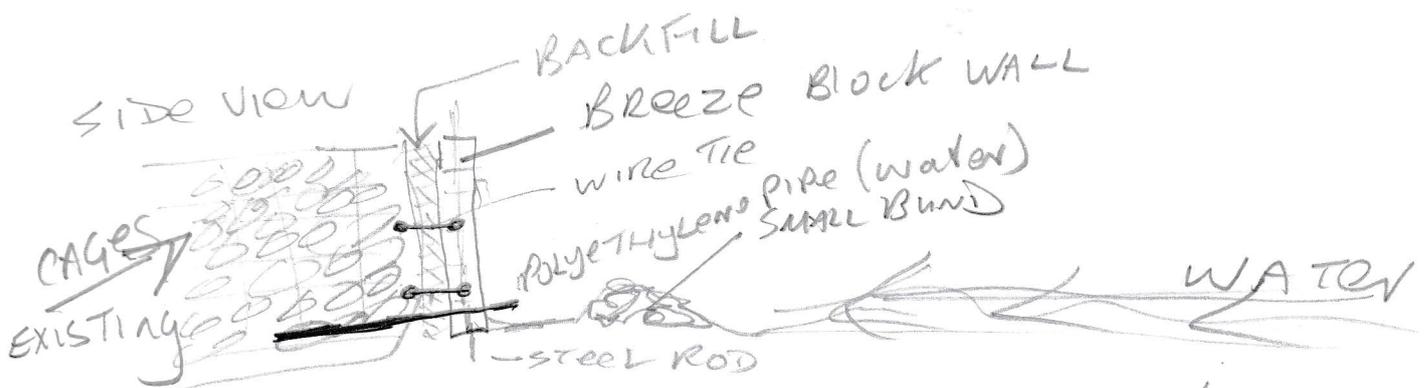
55 METRES APPROX

Approx 55 metre length of existing wall required repair or reinforcement.

A secondary 1 metre high wall was built approx 6 inches from existing cages. The wall was built using breeze blocks which had steel rods were inserted into the breeze blocks. Each steel rod was then wire tied back to the existing cages.
